Providing Mechanical Support for Tank Cleaning Contractors

Providing Mechanical Support for Tank Cleaning Contractors - Case Study 1

Providing Mechanical Support for Tank Cleaning Contractors - Case Study 2

Providing Mechanical Support for Tank Cleaning Contractors - Case Study 3

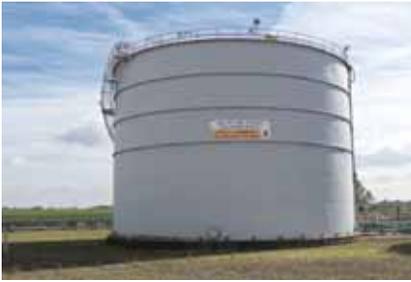
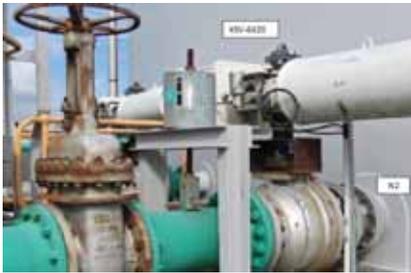
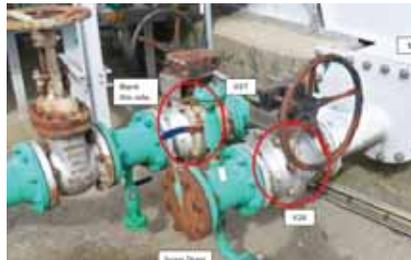
A West Yorkshire based waste management company had been awarded a contract to internally clean a gas condensate storage tank at a facility on the Saltend Chemicals Park in Hull. After cleaning the facility operator would be carrying out an internal inspection of the tank. The facility operator placed the responsibility for initial tank isolation with the waste management company as part of this 'fast track' contract. The tank isolation had to be carried out before the waste management company could commence any of their cleaning operations.

Following an initial site visit UECL (part of the Unit Birwelco group) provided a detailed method statement and risk assessment (RAMS) of how the tank isolation should safely be carried out. The waste management company submitted these RAMS to the facility operator for approval. In parallel with this UECL procured the bolts, gaskets and blinds required for the isolations. Within a short period of time UECL had provided: approved documentation, procured the materials and arranged the labour, plant and equipment needed for the work.

- ④ The removal of isolation valves and control valves ranging from 6" - 12"
- ④ Removal of 8" import lines and blanking off all open ends ranging from 2" - 12"
- ④ Installation of blanks and slip blinds ranging from 2" - 12"
- ④ Removal of 24" roof manways and other tank roof nozzles
- ④ Removal of 30" Shell side manways for tank entry

All line works were carried out using breathing apparatus.

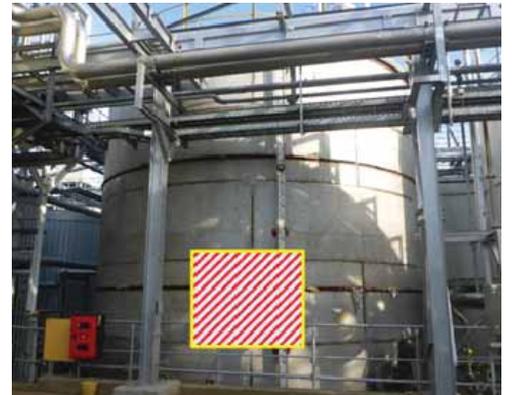
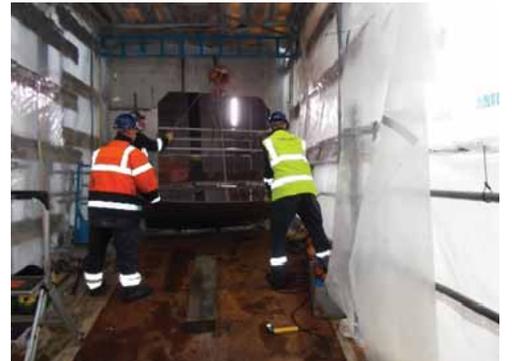
A Teeside based waste management and remediation company had been awarded a contract to remove solidified Formaldehyde from a Stainless Steel Storage Tank at a timber processing facility in Hexham. Conventional methods of tank cleaning couldn't be employed for this task, so a remote controlled mechanically operated machine had to be used for extracting the product. To enable machine access, a section of the tank shell would have to be removed and an anti slip ramp would need to be built up to the access hole.

Following an initial site visit UECL (part of the Unit Birwelco group) provided a detailed method statement and risk assessment (RAMS) of how the access door should be removed and replaced. This preceded further discussions with all parties including the client, the waste remediators and the scaffold contractors as to the placement of the ramp and how it should be constructed. The structural effects of 500 Tons of residual product on the integrity of the tank when the access hole was cut was also a key concern for the tank operator. The size of hole was proved acceptable through calculations provided by UECL. There were also further obstacles that had to be overcome by the remediation company to allow their forklift to access the tank by passing over existing pipelines. UECL provided tailored solutions for mitigating this problem. The remediation company submitted the RAMS and design proposals to the facility operator for approval.

- Pre-fabrication and installation of structural ramps and anti slip plates for forklift access
- Facilitating the cold cutting of the access door and removing it from the shell hole for scrap

- Supply and welding of replacement rolled stainless steel shell plate into access hole
- Carrying out emergent repairs to the tank shell following tank remediation
- Supply and Coordinating of NDT including shell seams X-ray following welding
- Removal of all structural steel & assisting with full demobilization to allow the tank to return to operability

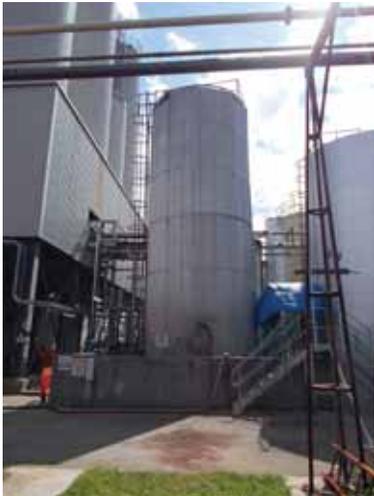
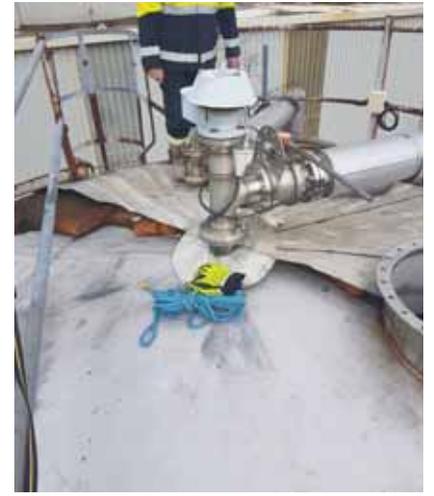
A Teeside based Waste Management and Remediation Company had been awarded a contract to remove solidified Formaldehyde from a Stainless Steel Storage Tank at a timber processing facility in Stirling. Over time the product had settled in the tank and solidified to such an extent that the tank shell had serious buckling and structural damage rendering it totally inoperable for future use. After the product had been removed the tank was to be demolished and removed from site. Once the product had been removed the tank was to be demolished due to it's poor state. The facility owner placed the full responsibility of the tank demolition and initial tank isolation with the waste remediation company as part of their contract. As the demolition was not something the waste remediation company had the expertise in (or the resources), Unit Engineers & Constructors Ltd (UECL) were invited to support them with their project.

During an initial site visit UECL (part of the Unit Birwelco group) risk assessed the impact of demolishing the tank in it's position surrounded by live plant and constant moving traffic such as tankers (significant hotwork would have been required). UECL advised against in situ demolition in favour of removing the tank as a whole and demolishing offsite. Due to the site layout a large 500T rated crane would be required to reach the tank, however following the cost analysis and risk assessment presented by UECL this solution was now the much favoured option from the facility operator. To enable tank lifting, some issues

had to be solved by UECL. The lower section of the tank shell had peeled away from the sub frame that supported the tank and there was a risk of this peeling completely when the tank was lifted. Another problem would be the amount of windows that were to be cut from the tank shell for cleaning access, there was a risk of the tank buckling once top and tailed onto the trailer plus a question of structural integrity of tank during cleaning. UECL provided the solutions for these hurdles following discussions and the issue of calculations and detailed method statements. The remediation company submitted the RAMS and design proposals to the facility operator for approval. At the remedial company's request UECL mobilised a squad of skilled and experienced mechanical resources, to safely and efficiently carry out:

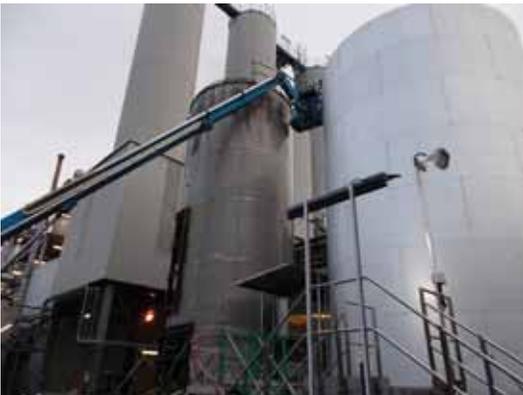
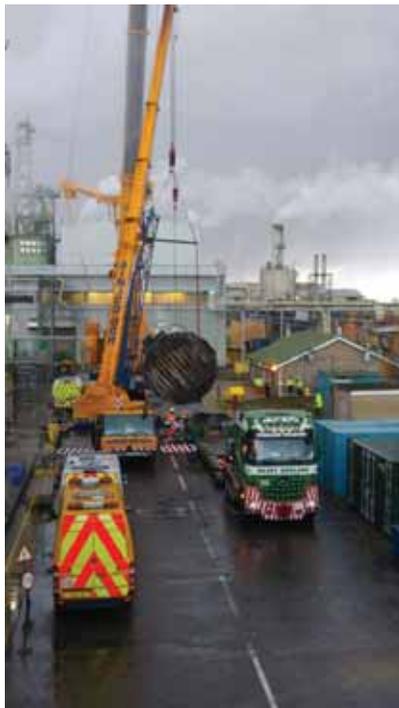
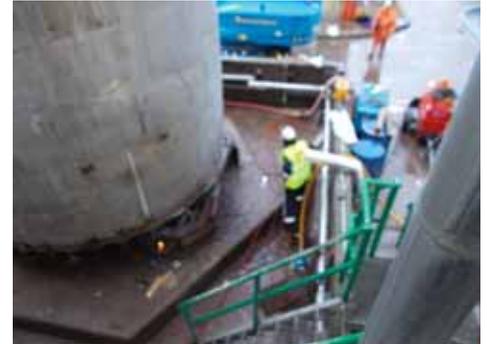
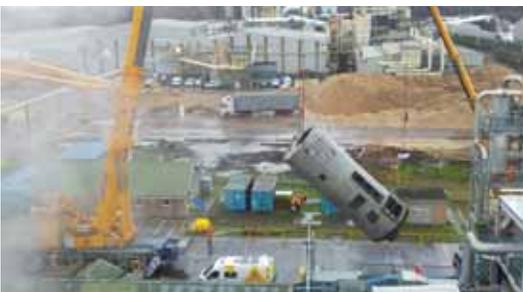
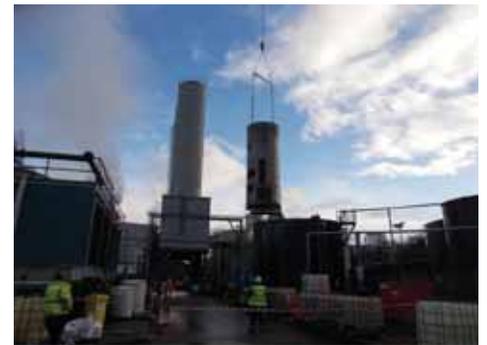
Throughout the 3 days it took to prepare and remove the tank from site there were minimal disruptions for the facility operator. This was major plus for the waste remediators ' client who had originally anticipated 2 weeks of in situ demolition with potential disruptions from hotworks, cranes and vehicles.

- ④ Supply and welding of straps for tie - ing the subframe back to the tank—to prevent it peeling from the tank when lifted
- ④ Supplying and welding of bracing around the access windows that had been cut into the tank—to prevent the tank buckling during top and tailing
- ④ Mobilisation of 500 T crane supplied from the Heavy Lift Division of UECL ' s approved and trusted crane operator
- ④ Lifting and removal of the tank from it ' s bund
- ④ Final siting of crane onto waiting trailer and removal from site for demolition
- ④ Removal of all structural steel and assisting with full demobilization
